Wildcat Cove Drone Survey

Final Report

David Wallin

Department of Environmental Science

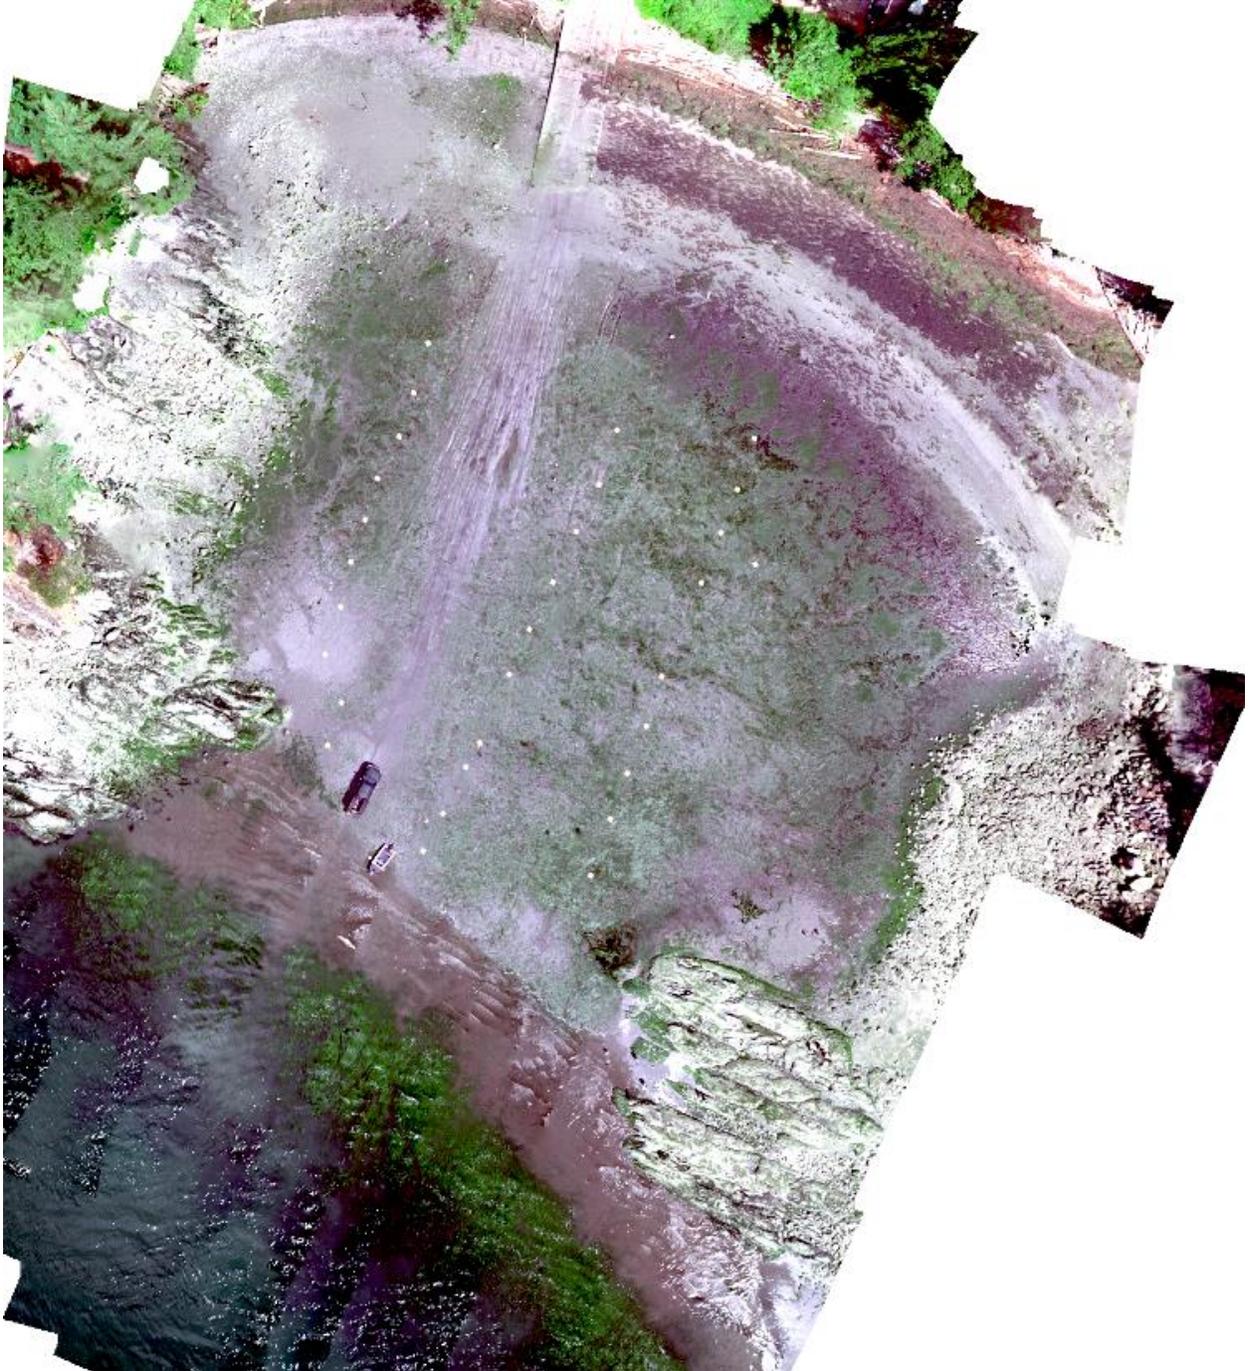
Figure 3: Color imagery for Wildcat Cove at ~noon on July 17, two days after the opening of crabbing season. Tide stage ~ -1.8 ft. Sun angle 57 degrees. Note wider denuded track through eelgrass created by boat launch activity as well as track through the subtidal eelgrass.

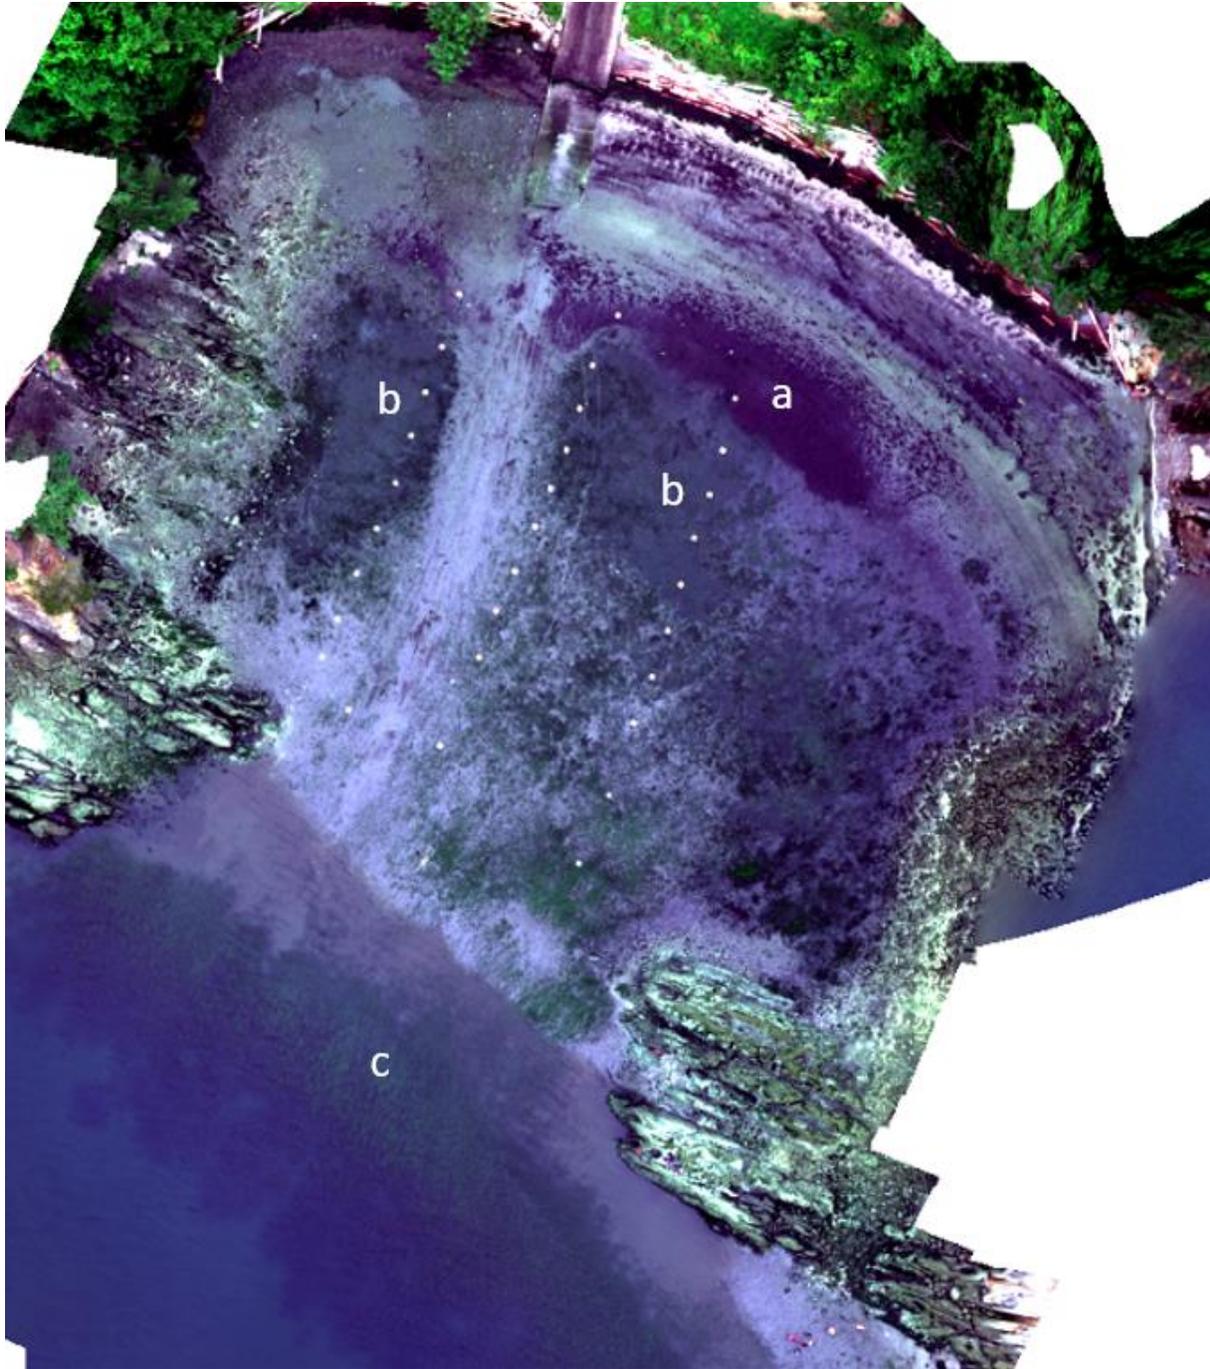
Figure 5: Color imagery for Wildcat Cove at ~9:15 on August 28. Tide stage ~ -2.0 ft. Sun angle 27 degrees. Note that, as is typical for this time of year, eelgrass is beginning to senesce throughout the cove and there is a large area of dead eelgrass washed up on the upper beach (a). 100% overcast conditions on this day resulted in some glare from shallow water (b) that resulted in anomalous vegetation index values from these areas. For this reason, ground control plots from these areas were not used for modeling. Typical seasonal decline of subtidal eelgrass is also apparent (c). Denuded track through eelgrass created by boat launch activity is still present and is expanded to some degree.
