Wildcat Cove Mapping Report

Survey Conducted for the Whatcom County Marine Resources Committee

Washington Department of Natural Resources

November 7, 2023

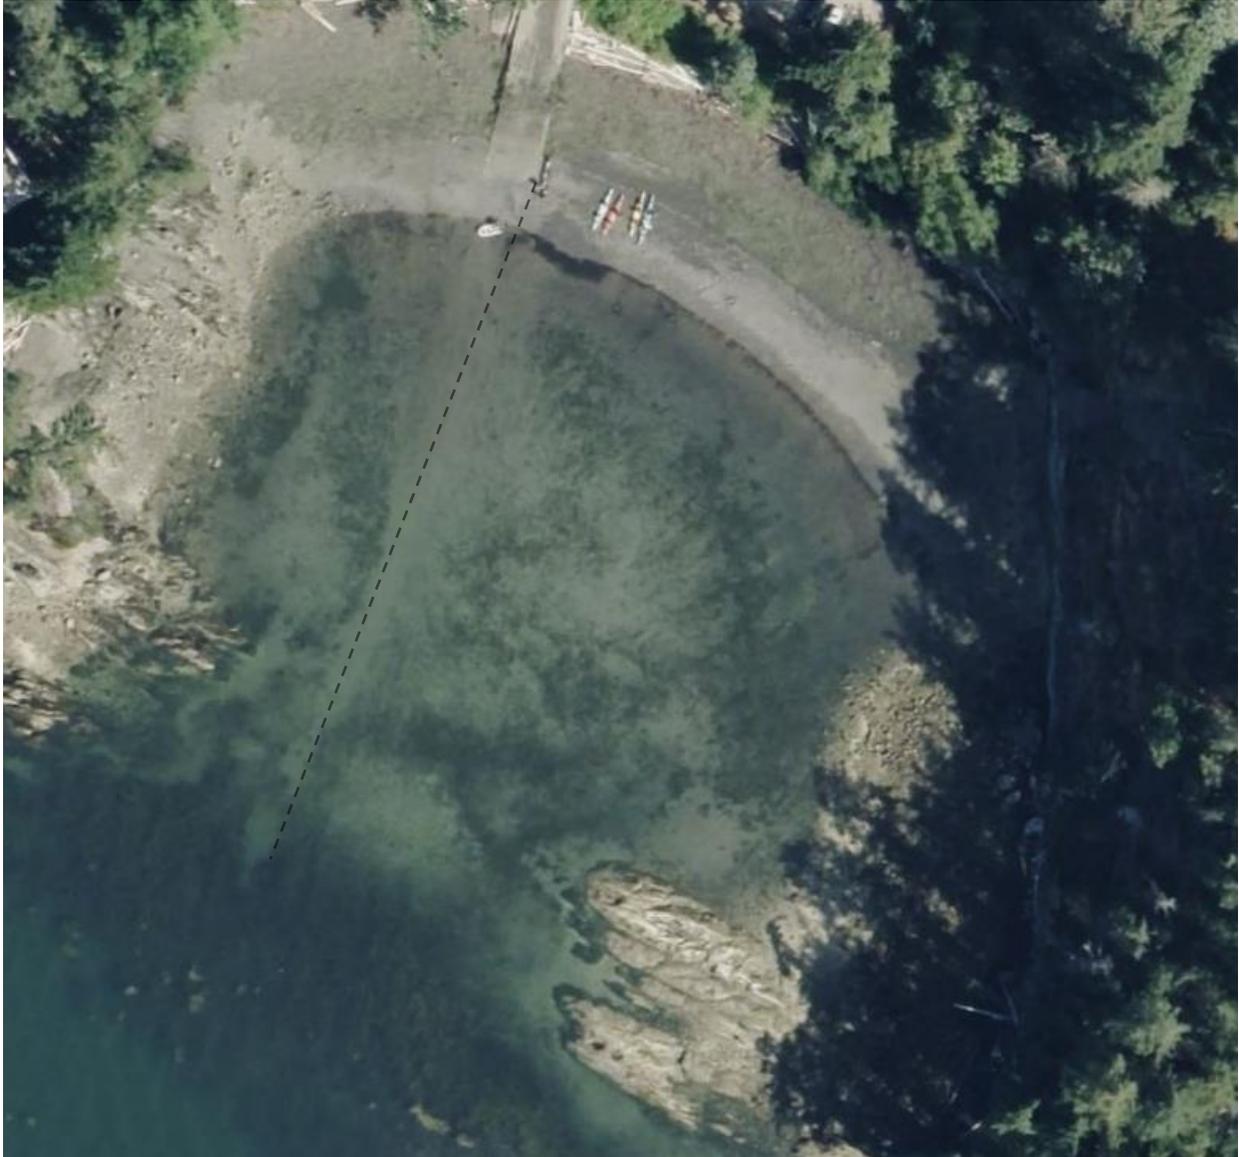
Figure 1. Wildcat Cove at a relatively high tide. Within the zone of intertidal truck/ trailer travel (hashed line) there is a visible lack of eelgrass. Satellite photo from Google Earth.

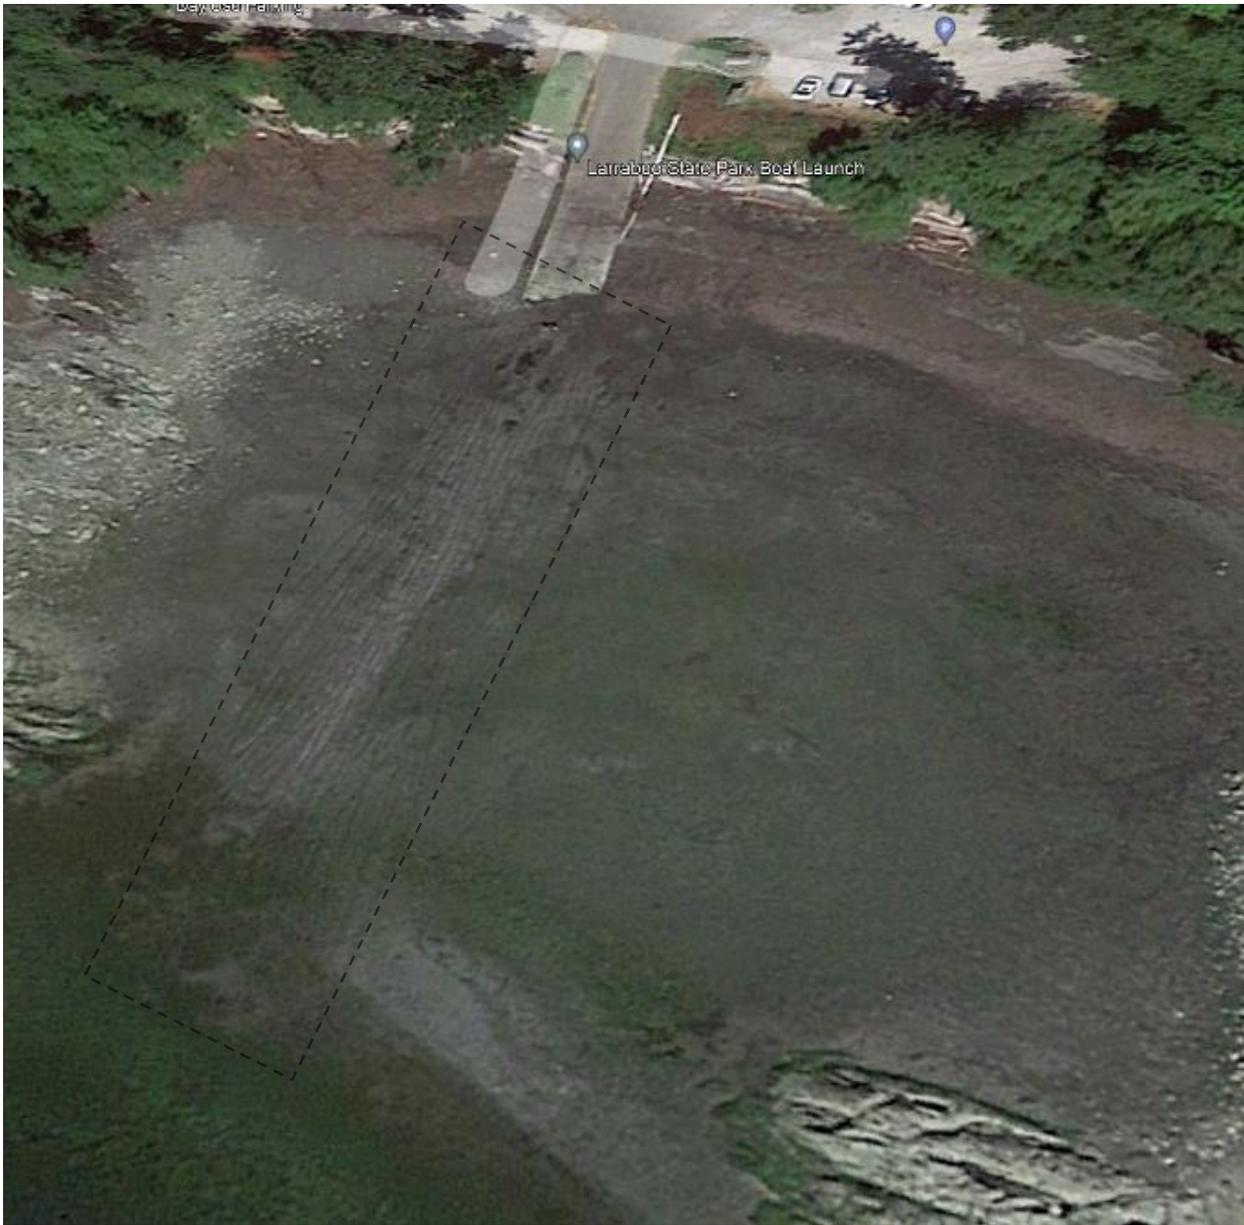
Figure 2. Wildcat Cove during summertime (July 2017) low tide. The tide is at an approximate low of -2 ft. MLLW, and tire depressions are obvious within the trajectory of the boat launch (within hashed box). Satellite photo from Google Earth.

To reference field data to the area of expected impact, a polygon feature class was created in Google Earth and exported to a feature class using the .kml to feature class tool in ArcPro. This polygon “Intertidal Boat Launch Impact Zone” was defined to include where truck and trailer tire imprints were visible at low tide in satellite imagery from July 2017 (Figure 12).

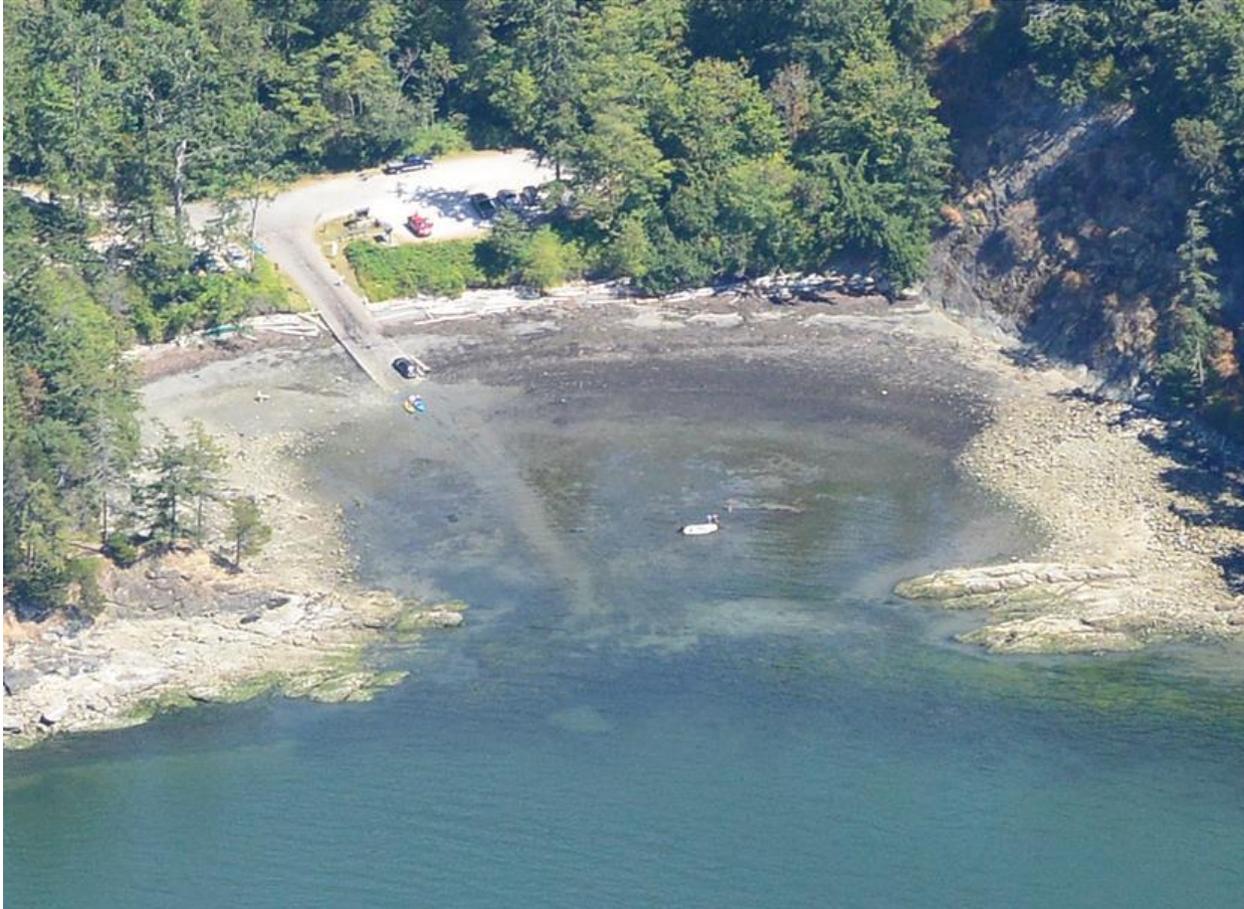
Figure 3. Another view of Wildcat Cove. Visible is a strip of missing eelgrass in the trajectory of the boat launch. Image from Department of Ecology Shoreline Photo Viewer.

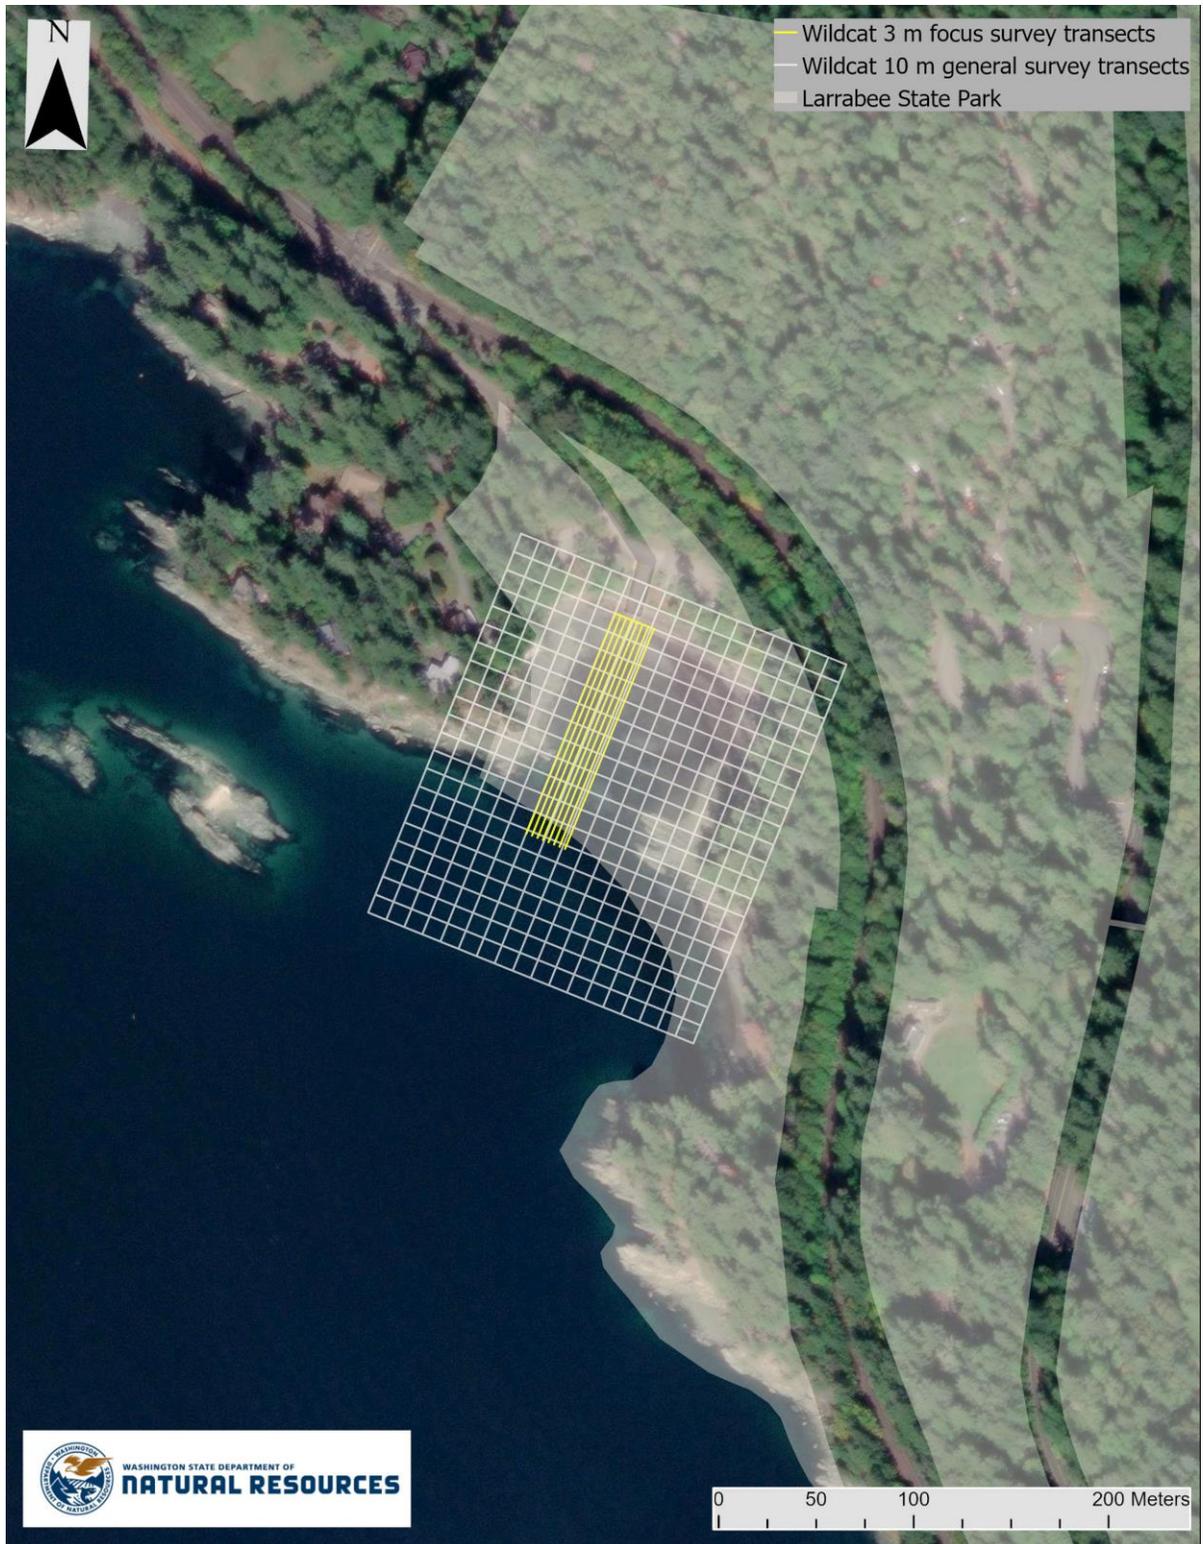
Figure 4. Single beam sonar transects, Wildcat Cove - Larrabee State Park.

Single beam sonar transect lines were set up to cover the entire cove at a resolution of 10 meters. Focused survey lines at 3 meters were planned around the boat launch (Figure 4). ArcGIS Pro was used in the planning process to create transect lines using the create fishnet tool (Figure 4). Transect lines were transferred to a survey computer for the boat operator to use as a guide.

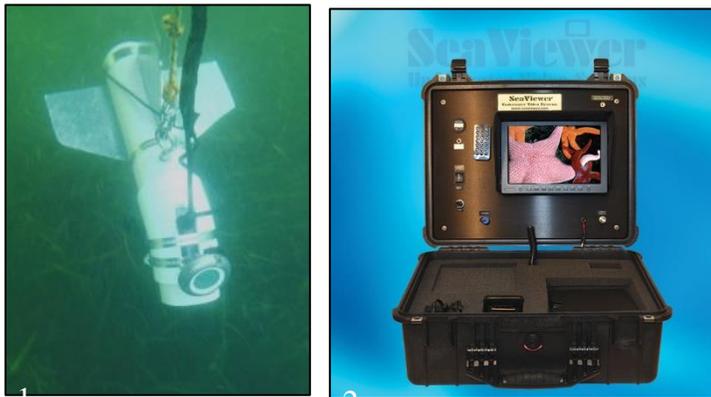
Figure 6. Left: Seaviewer Camera. Right: Seaviewer Surface Unit and Recorder Interface

The towed camera is housed within a PVC enclosure which orients it at a 45 degree angle to the bottom, protects the camera from potential damage, and allows the camera to track straight with the use of fins and weights (Figure 6). To maintain a constant field of view, the camera is held about 1 m from the benthos.

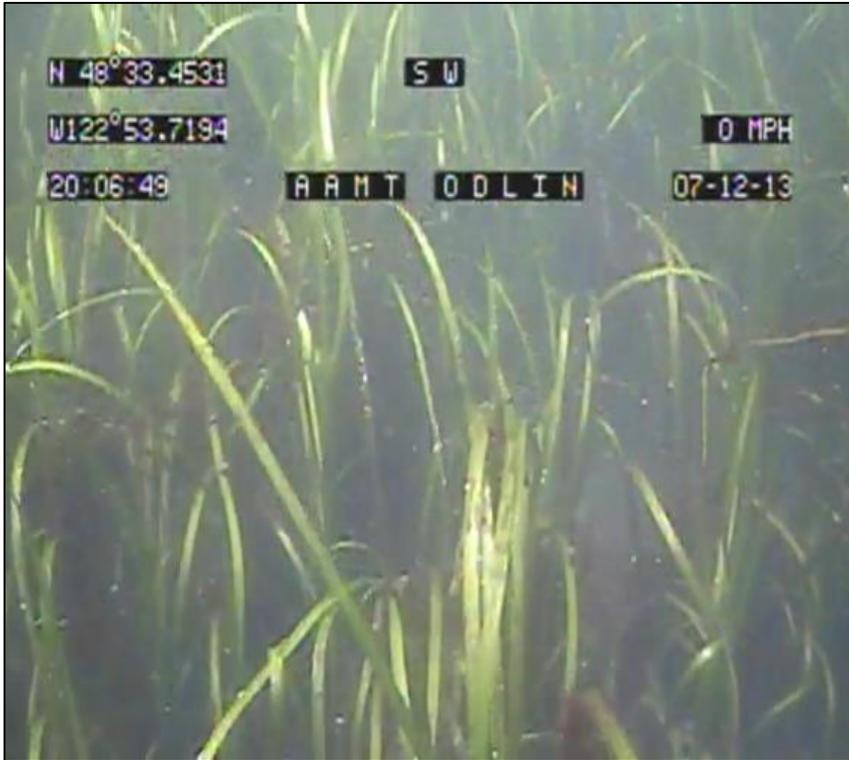
Figure 7. View of real-time video collection and attributes

BioSonics software interprets a unique sound return for eelgrass; however, there are anomalous features that may be misinterpreted as eelgrass when post-processing (Sabol et al., 2002; Shuai Xu, 2019). To verify eelgrass presence, we collect underwater video along 10% of the transects surveyed. For these transects, video can be collected while the sonar is also running by towing a SeaViewer Sea-Drop 950 video camera weighted and suspended by line off the port side of the boat. In real-time, a SeaViewer Sea-Trak GPS overlay displays time and GPS locations onto the video image (Figure 7). Video data is recorded digitally on an SD card with a SeaViewer DVR-SD.

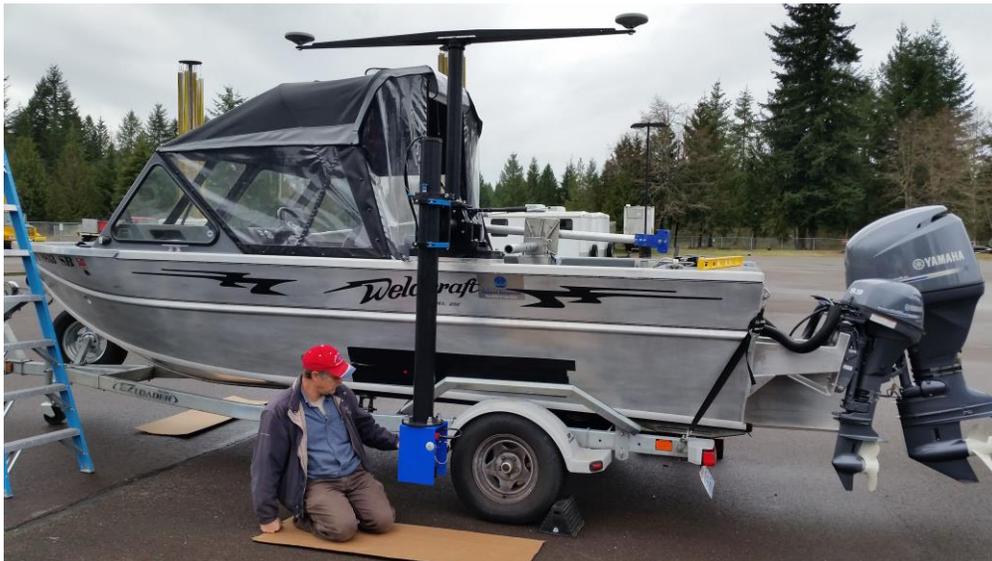
Figure 9. RV Neap

An R2sonic 2020 multibeam sonar and an integrated Applanix navigation system was utilized for bathymetry. The R2Sonic 2020 model is a small and light flat-array multibeam unit that combines the transmitter and receiver into a single instrument. Position, heading, pitch, yaw, and roll are recorded with an Applanix Inertial Motion Unit (IMU) and Trimble GNSS positioning system. Using Applanix’s POS PAC software (Applanix Corporation 2021) DNR scientists are able to collect raw motion and heading data in the field, process these observations in the office, and recalculate the entire survey’s data for high-accuracy three dimensional spatial locations.

Data was collected at a 400 kHz frequency, with a beam width of 130 degrees. At least fifty percent data overlap was collected between tracks. The survey was planned and carried out with QINSY software by QPS Maritime Software Solutions. Sound speed calibration casts were taken every 2 hours with a Sontek Castaway CTD.

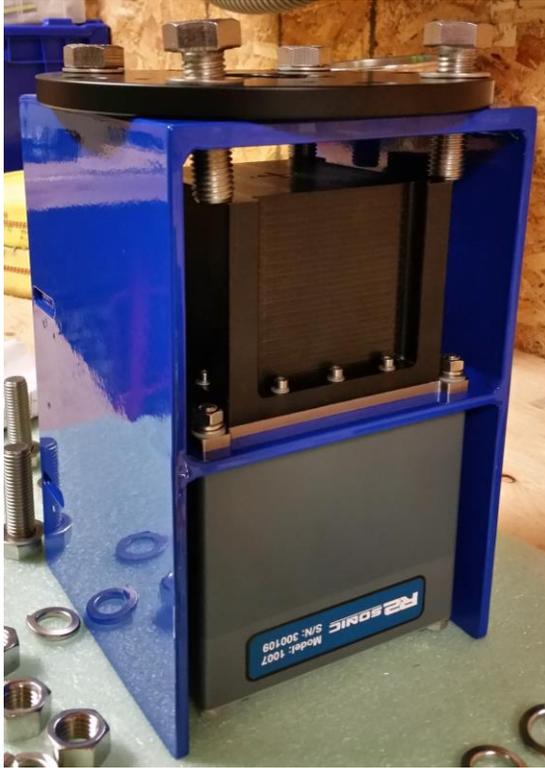
Figure 10. R2Sonic 2020 multibeam (bottom, grey), Applanix IMU (top, black), and mount (blue)

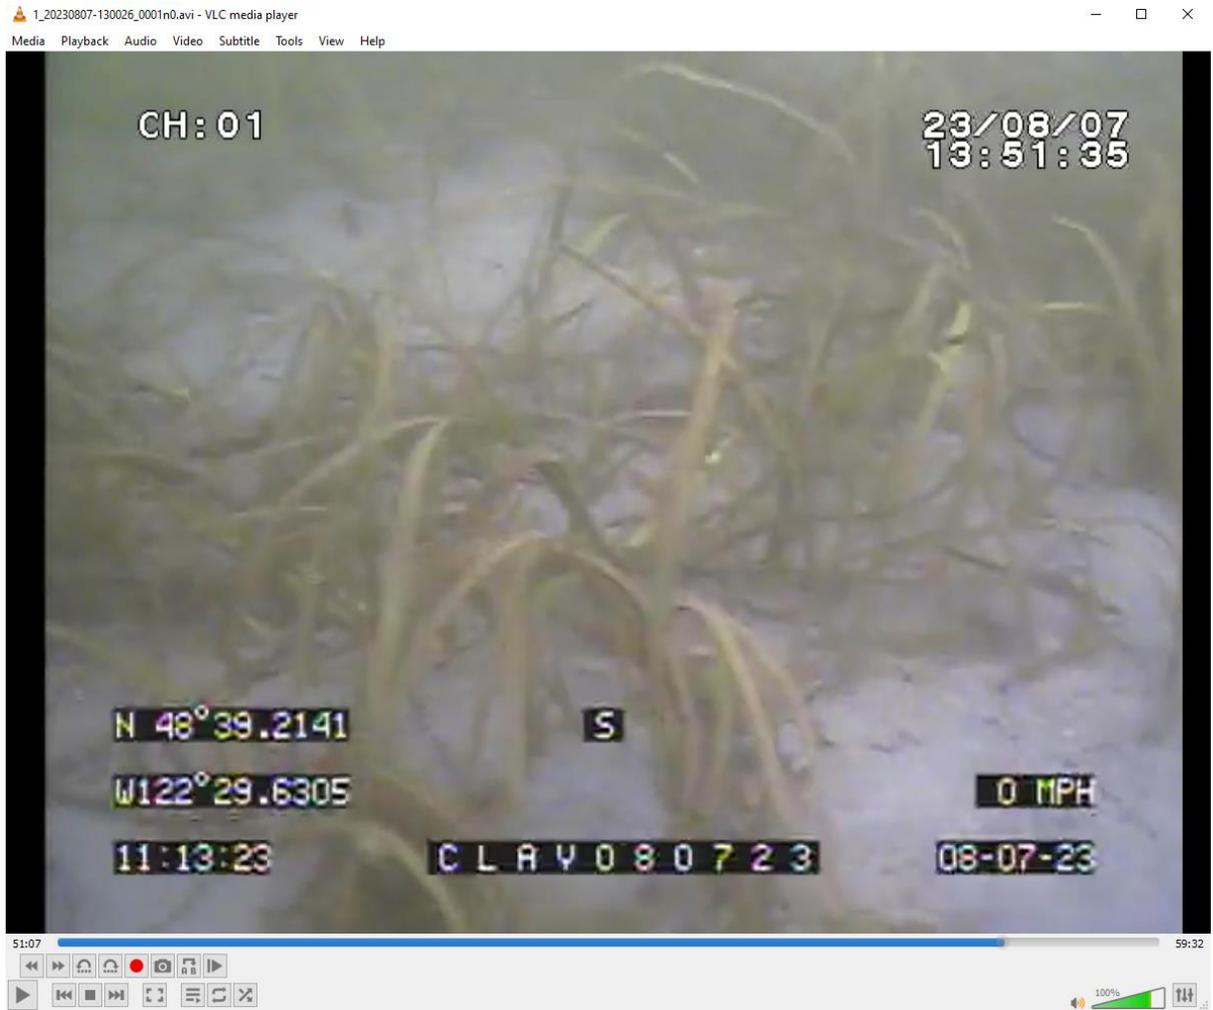
Figure 14. Eelgrass from video survey - this sample is from within the -10 to -2 ft. MLLW zone.

Single beam sonar data corroborates data from the multibeam sonar, and shows the same pattern of dense, deep, eelgrass from -10 to -2 ft. MLLW within a narrow band and fragmented, short eelgrass (*Z. marina spp.*) within the flats of the cove (Figure 16 and Figure 17). Figure 14 and Figure 15 are snapshots from video, and represent eelgrass that was found in a deep band (Figure 14), and that which was found in shallow portions of the cove (Figure 15).

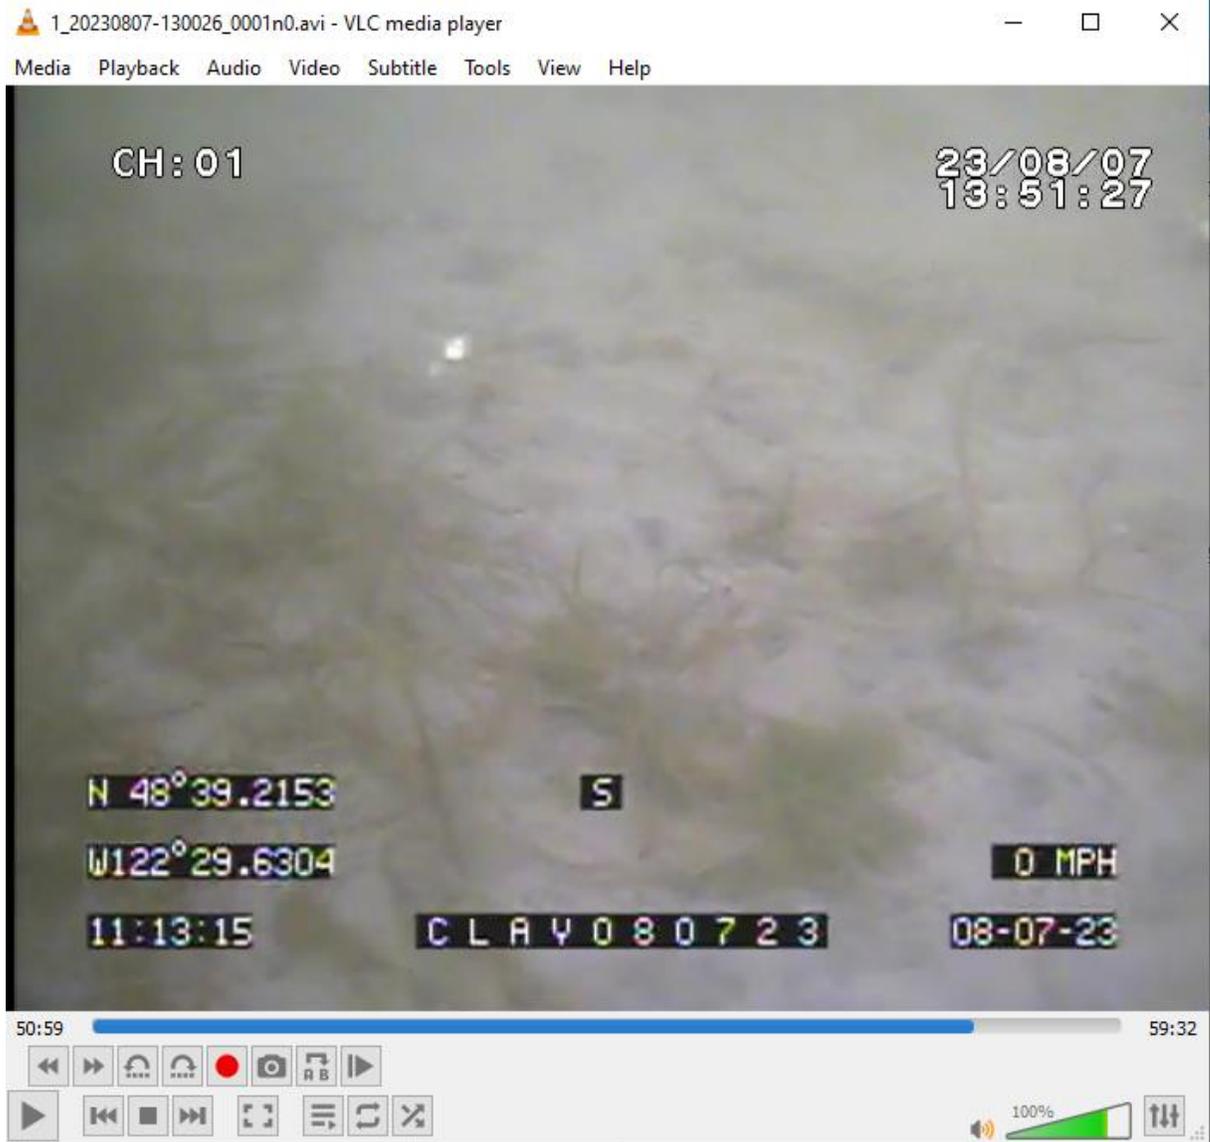
Figure 15. Eelgrass found in the upper regions of Wildcat Cove was patchily distributed and short such as the sample in this screenshot.
